Maryland Materials Playgrounds

Playground Safety Inspection Report

Site Name: SITE NAME
Location (City, State): LOCATION
Areas: AREA
Date of Inspection: DATE

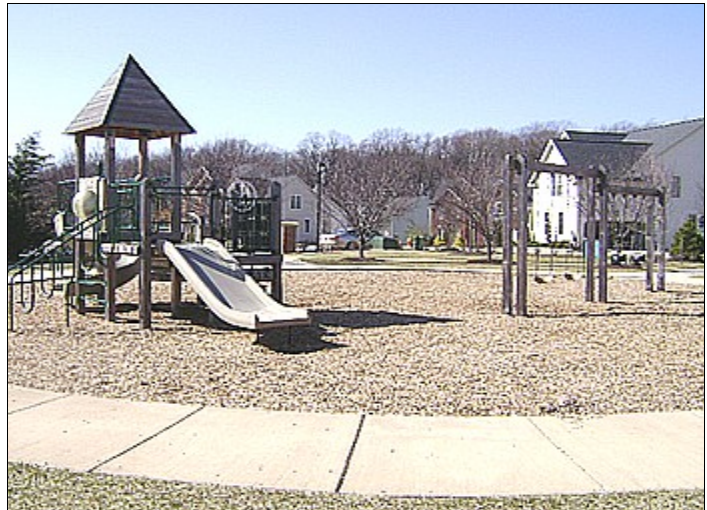
The playground has an elliptical shape, and it is surrounded by a concrete walkway, which is the only border around the playground. There is no fence around the playground, and there is no overhead shade cover. The playground is located approximately 100 feet from the nearest road.

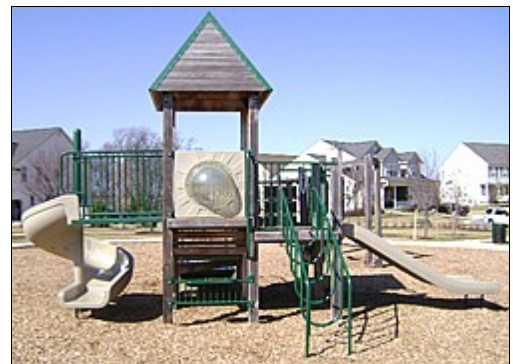
One (1) Modular Play Structure. Manufacturer: *Name*. The vertical posts are made from wood, and the components are made from steel, roto-molded plastic, and polyethylene. The structure's footprint measures approx. 21' x 16'. The vertical posts measure 5" x 5". This structure has 3 platforms located 46", 54", and 63" above ground level. It has the following play events: 1 open spiral slide, 1 straight, double-wall wide slide, 1 inclined half circle climber, 1 bubble panel, 1 vertical tic-tac-toe panel, 1 horizontal tic-tac-toe panel, 1 rung wall with steering wheel, and 1 store panel.

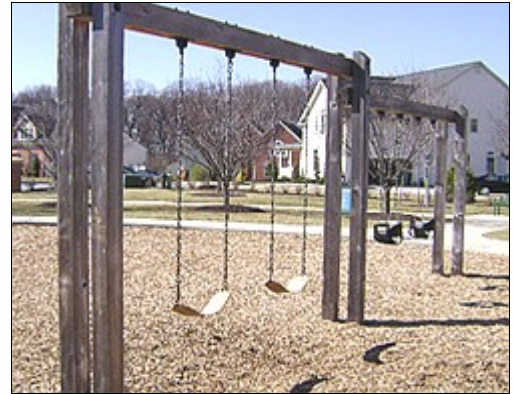
One (1) Swingset Structure. Manufacturer: *Name*. The swingset is a single-post, to-fro model. The structure is made from wood, and its footprint measures 20' x 18". Its vertical posts measure 5" x 5" outside diameter. The swingset has two bays. One bay contains two belt seats with grommets; the other bay contains two fully enclosed infant seats with extra back support. The swing hangers are bolt-on models with built-in pendulums. The swing hangers connect to the top of the swing chains with S-hook connectors. The swing chains are made from galvanized steel. The swing chains for the belt seats measure approximately 68" long, and the chains for the infant seats are approximately 40" long. The bottom of the swing chains connect to the swing seats with S-hook connectors.
